Mt. Pleasant Fire Department

Occupancy: **WALMART**
Occupancy ID: **50A**
Address: **2311 JEFFERSON Mt. Pleasant TX 75455**

Form: MPFD Inspection Form - NEW

Inspection Type: **Reinspection**
Inspection Date: **1/9/2026** By: Evans, Charles
Time In: **14:56** Time Out: **21:00**
Authorized Date: **01/09/2026** By: Evans, Charles

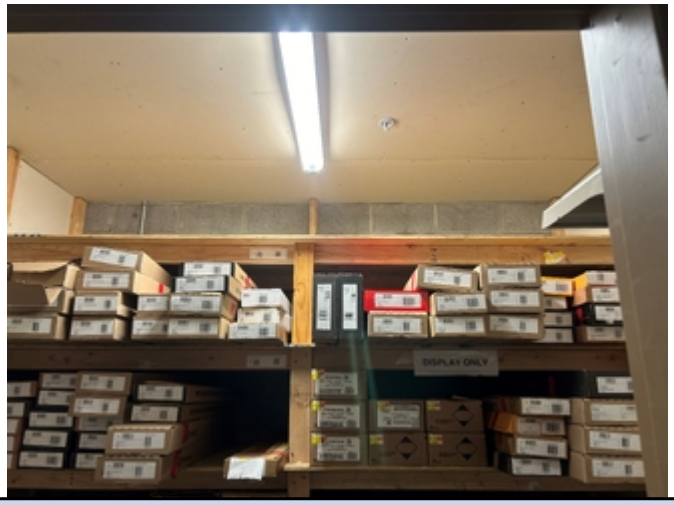
Status: PASS
Notes: There is no way for the water to access the lower parts of the storage rack if something were to catch on fire. I would recommend wall mounted sprinkler heads or having a wire style storage racks.
Also there needs to be an (explosive) placard on the door of the room where the guns and ammo is stored.

Re visited on 12/3/2024. Still not taken care of.

Corrected as of 1-9-2026 The Sprinkler head has been relocated to point towards the wooden rack.
Note: Advised store manager to place a sign on the door entering the ammunition area stating "Live Ammunition"

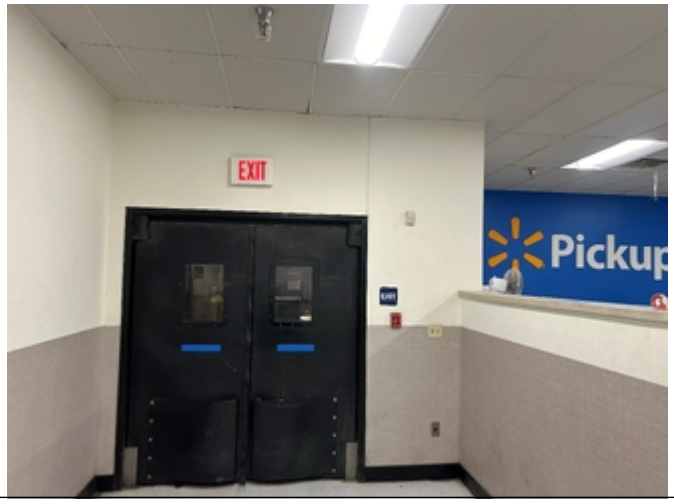
Status: PASS
Notes: These doors are located in the photo lab. We ask that there is a "roof access " sign mounted here and on the fence that goes to the roof access ladder. Preferably a 12x12 sign with 2 inch letters.

Corrected as 1-9-2026
