Roof-project photographs: July 10-August 19, 2025

Source: September 3, 2026 evidence addendum, PDF pages 39, 40, 41, 42, 43

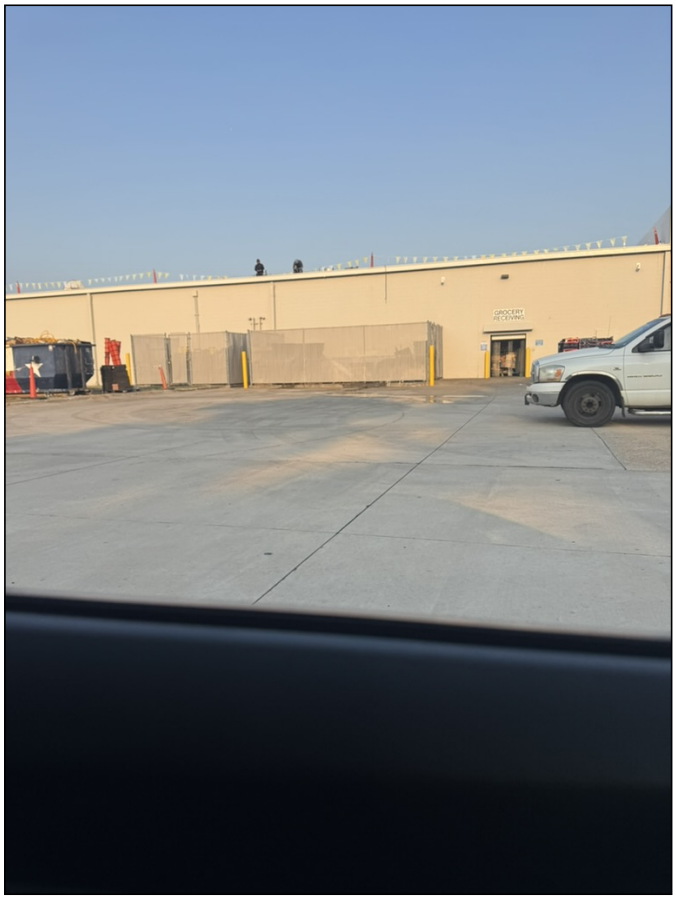
Plate AA-4: Multiple containers and roof activity

August 7 views show multiple containers and active work at the roof edge near grocery receiving. These images support the continuing-project chronology and a request for the precise scope and controls used after the positive mastic result.
