August 1 roof-work video stills

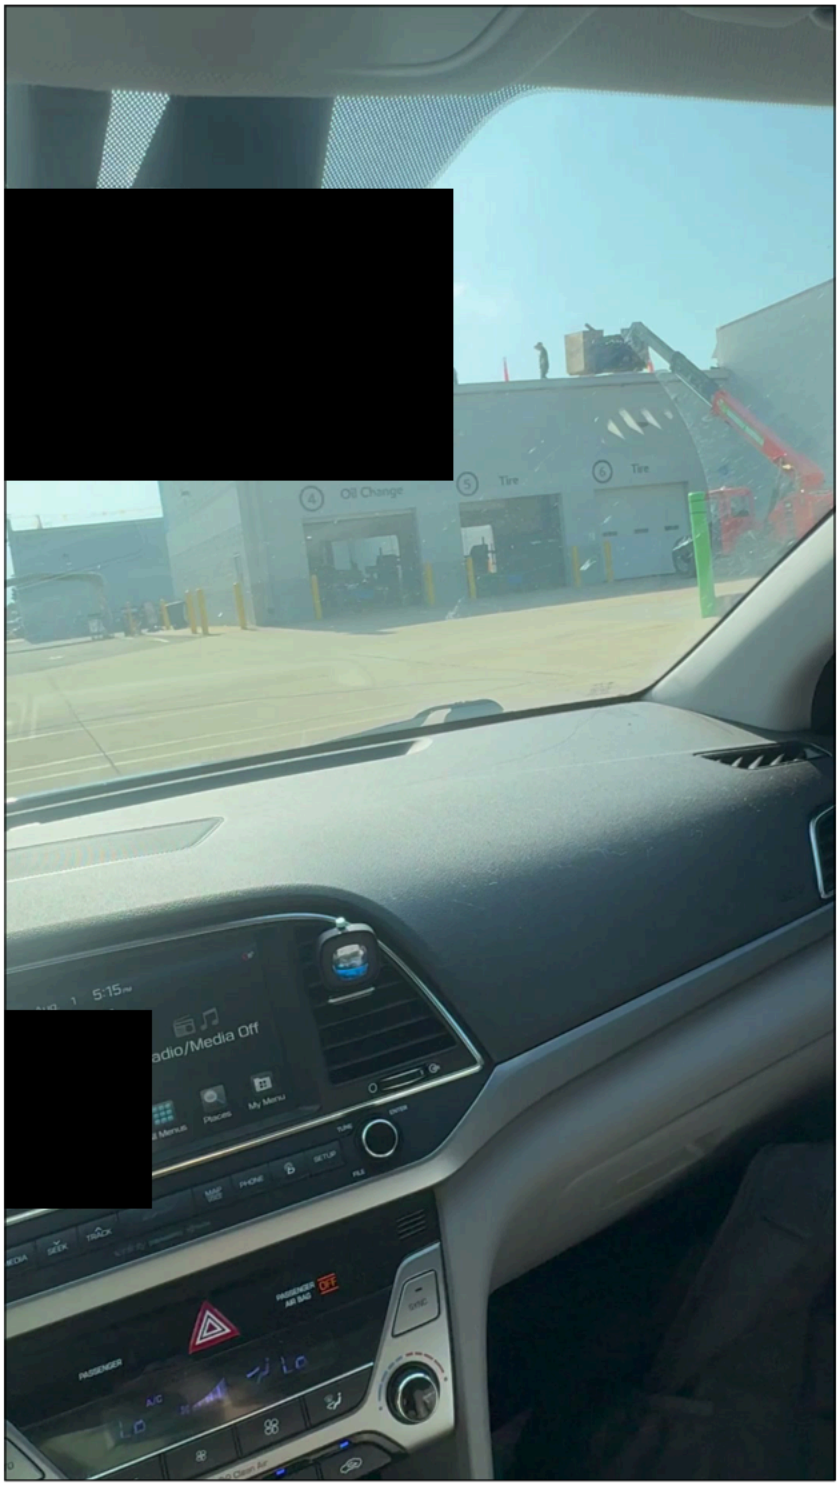
Plate Y-1: Carrier positioned at roof edge

IMG_1599.MOV at approximately 00:15. A telehandler and plywood-sided carrier are positioned at the roof edge during ongoing roof work. The frame establishes use of the carrier in the roof-work area but does not establish the composition of the material being handled.

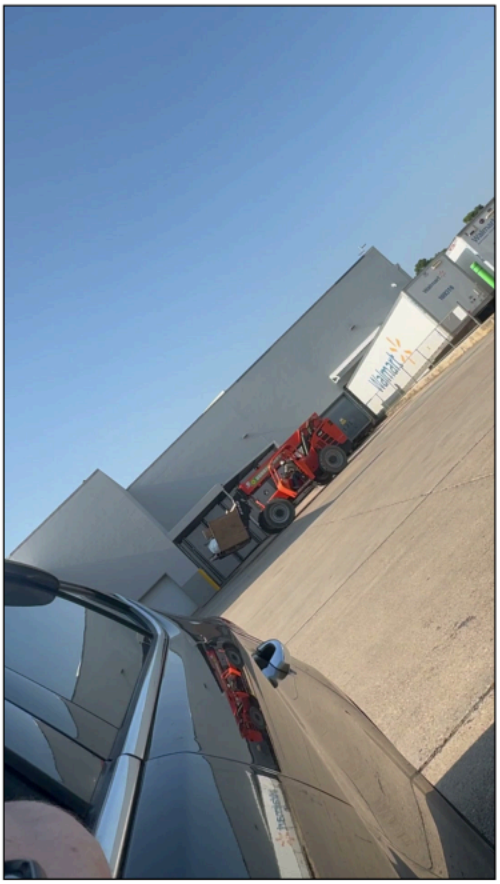
Plate Y-2: Continuation of roof-edge sequence

IMG_1603.MOV at approximately 00:15. The carrier remains at the roof edge with a worker nearby. The image is part of the same sequence and does not independently identify the material being handled as asbestos-containing.
